TRAACA Tech Day: Front Axle Bearing Replacement By Craig Brown

March 9, 2013 at Bill O'Rourke's Garage

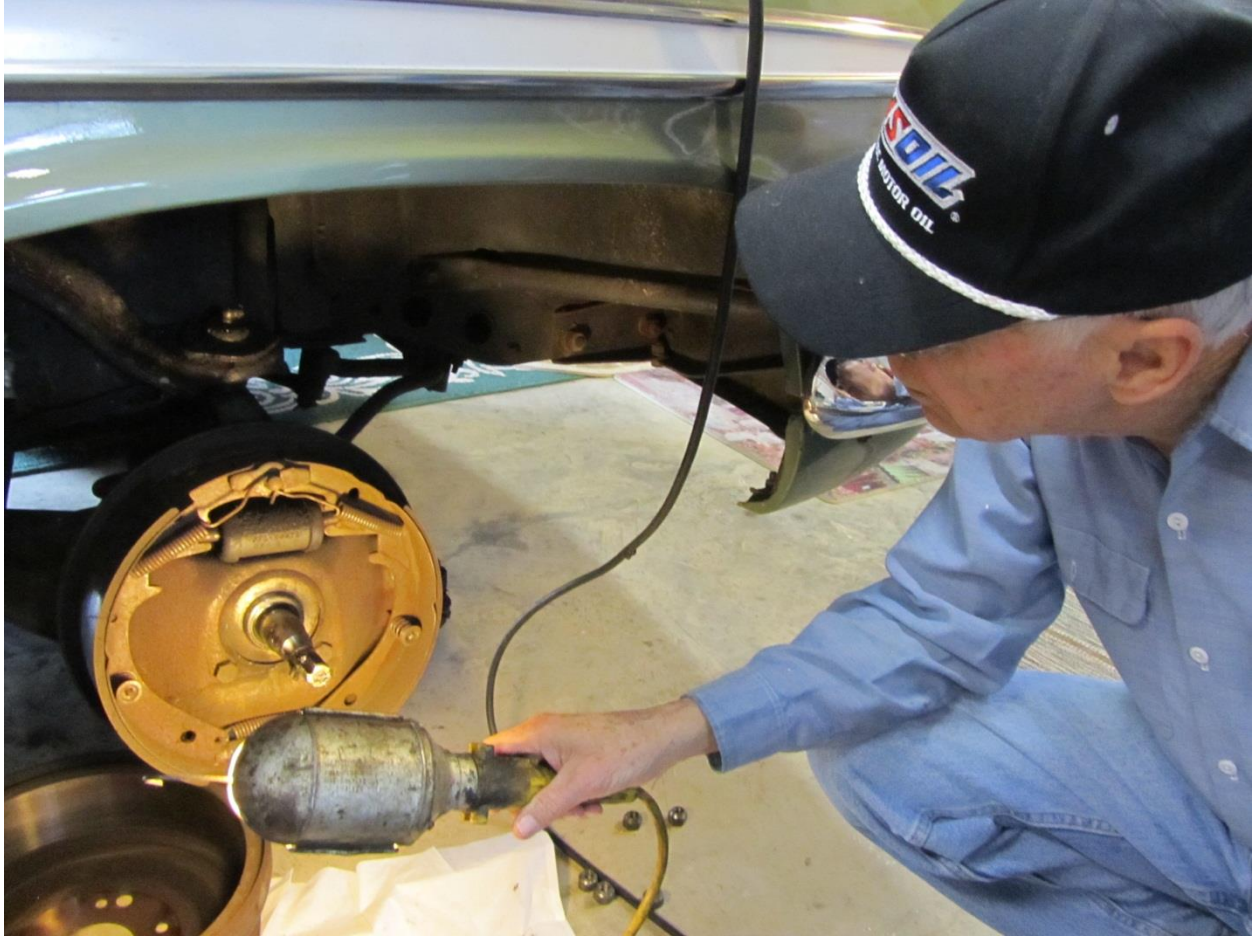
Bill O. got to work on removing the wheel and front brake drum with assistance from this author. The outer bearing race was removed and the hub containing the bearings. Bill Brundyge inspected spindle and it was deemed to be in fine shape.

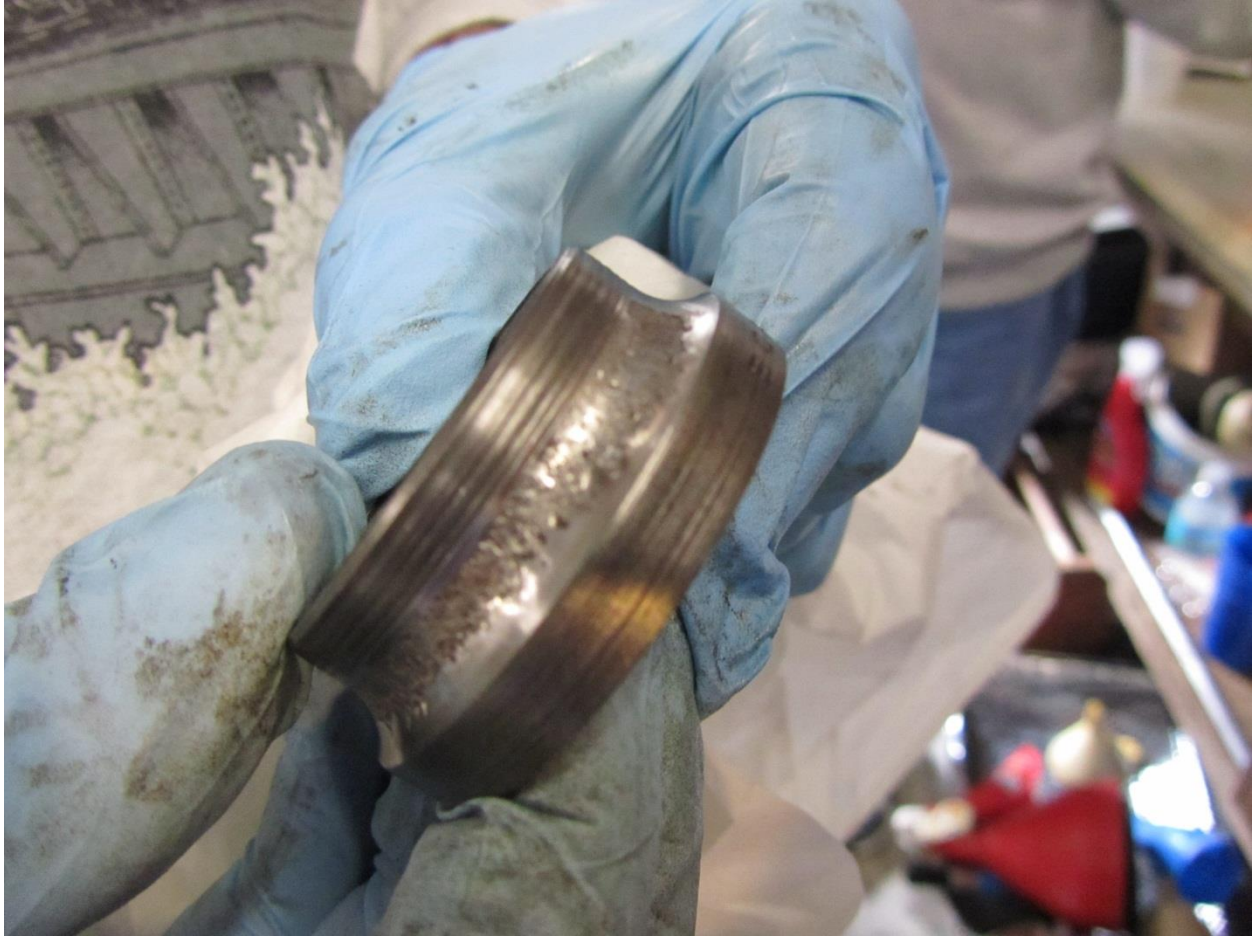
The inner bearing race felt rough to the finger test, but once it was cleaned of grease the reason for the noise was clear. The race had deep galling.

We were able to read a clear part number off the inner bearing race and Bill O. began making his parts needed list. A trip to NAPA would be required to order the correct parts. The crew celebrated the accurate diagnosis and verification of that diagnosis with coffee and donuts.

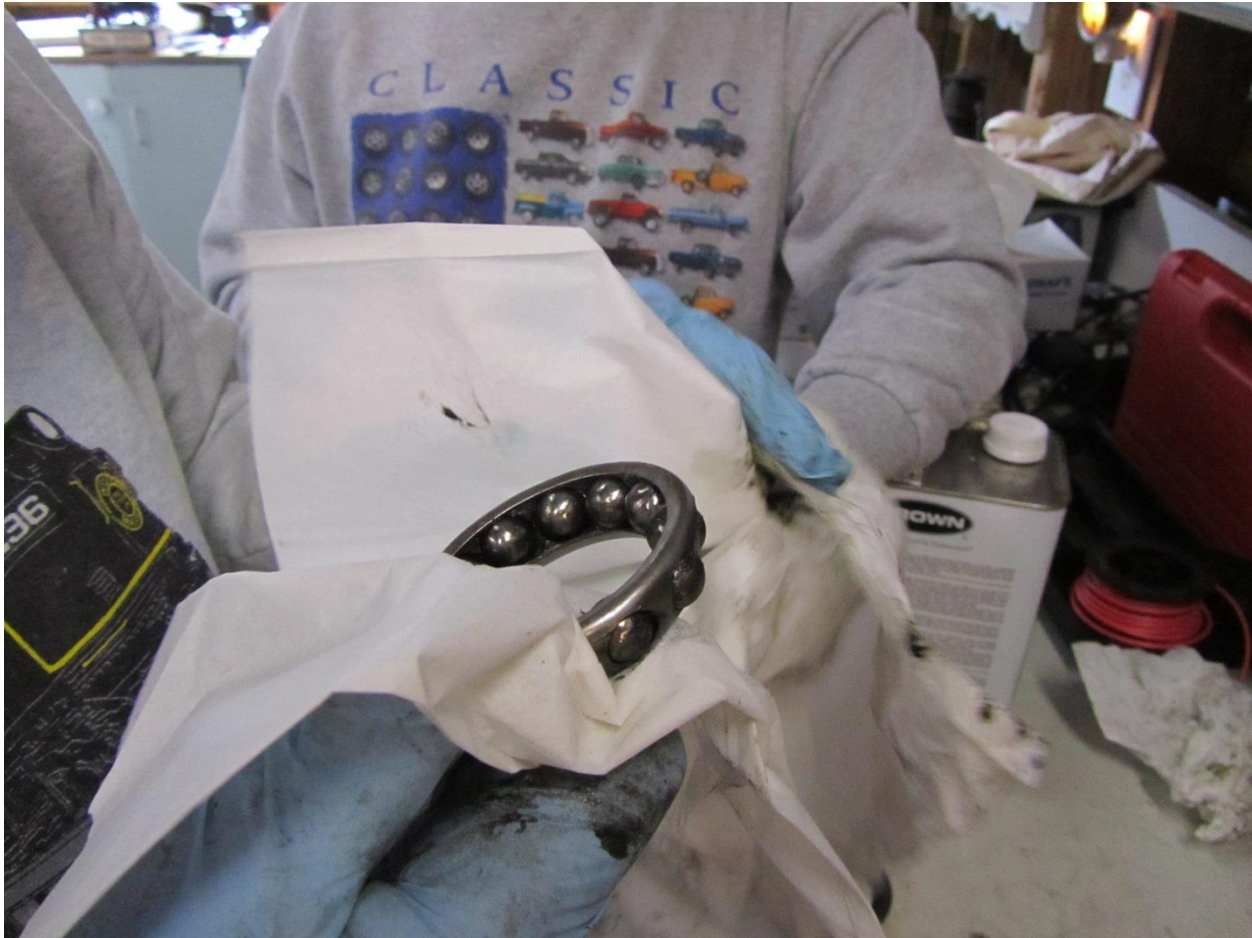
As the bearings were lifted out of the hub for inspection, the Model A owners began to get excited. The 1959 Chevy had been riding around on round ball bearings just like the Fords from the 1930s! No fancy taper roller thrust bearings needed here—if it was good enough for granddad, it's good enough for us. The outer bearings and races were in very good condition, the inner bearings had taken all the wear-and-tear.

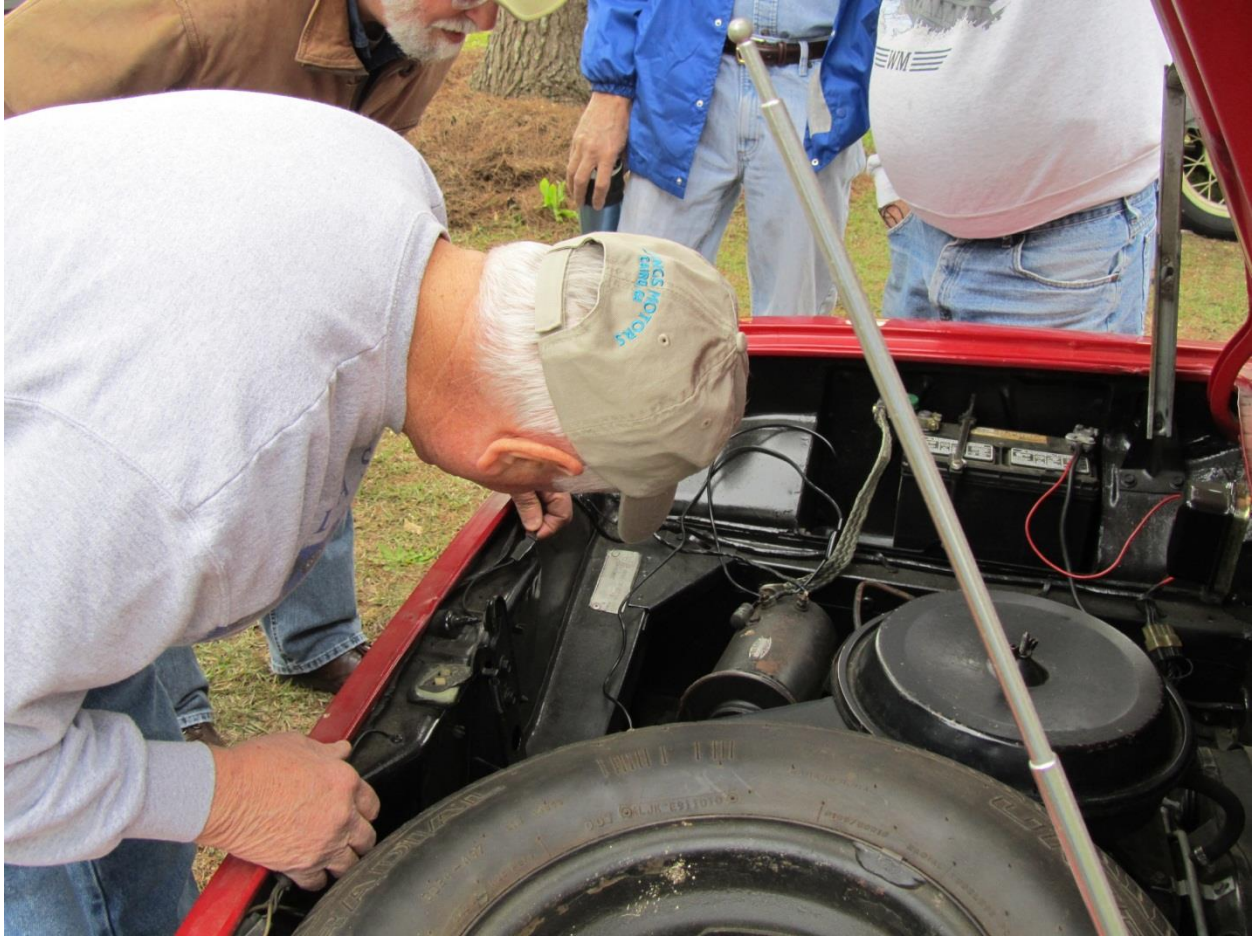
A jumper wire, or 'hot wire' as known by the former juvenile delinquents in the group, was attached from the battery to the hot side of the coil. This allowed the Corvair to start and run just fine. Something was happening in the wiring, connectors or ignition switch to starve the ignition circuit of vital electrons.

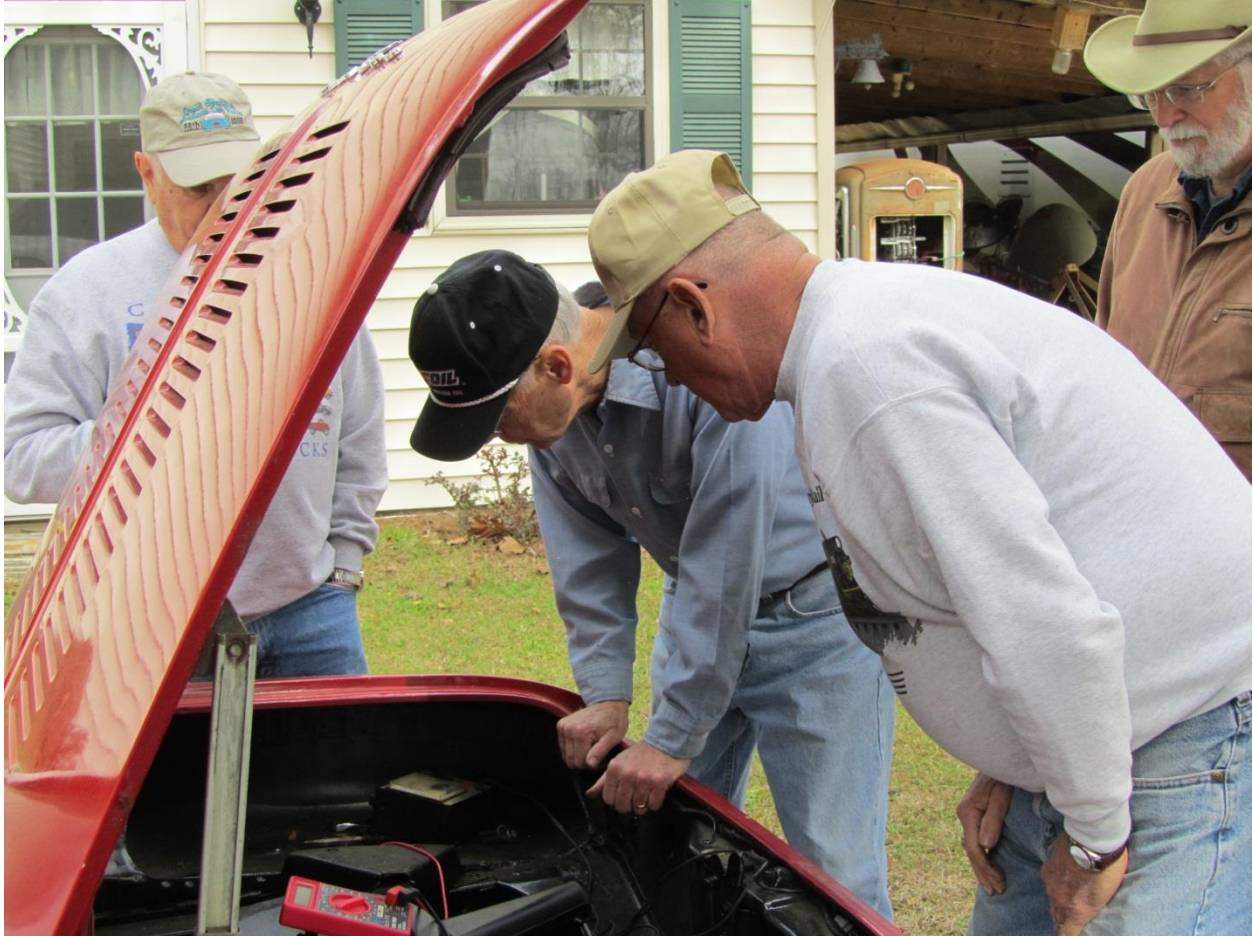
The next step was to bring out the test light and start probing. The light glowed, but not always brightly. A volt-ohm meter was fetched to get more scientific readings. The 12 volts at the battery was down to 4.62 volts by the time it reached the ignition coil. This Corvair has no ballast resistor, so that was eliminated as one of the usual suspects. Where were those missing electrons?

The distributor cap was removed and the points checked out. A dwell meter was hooked up and the dwell checked out with the hot wire in place to allow the engine to start. The battery was then charged to full capacity just to make sure it was up to the task. The Corvair still would not crank without the hot wire in place.

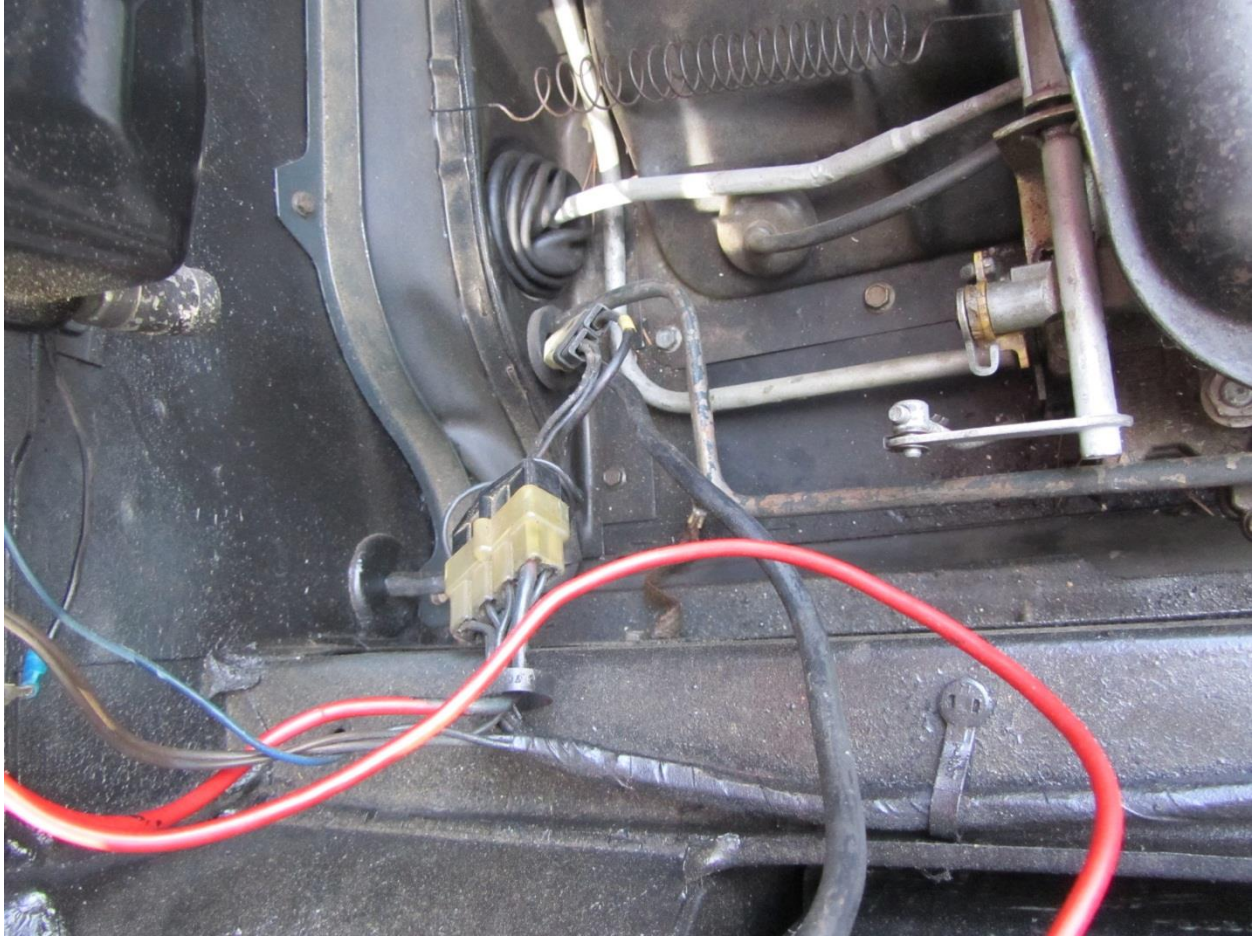
The group was getting restless and some members had to leave to fulfill other obligations. Bill B. and Ed Shuler would not give up. They traced every wire in the engine compartment, cleaned contacts and measured voltage drops. The black connector to the ignition switch was checked and it was fine. Someone pointed to the large clear connector (see in picture below) in the wiring harness and suggested disconnecting it and checking for corrosion. Once the connector was unplugged and re-seated, the Corvair would crank on its own and the voltage at the ignition coil rose to 10 volts (from a previous 4.62 volts).

The lesson learned is don't forget to check the connectors for both corrosion and proper contact when tracing an electrical circuit. Check for voltage drop across the connector in case it is a poor, but not completely broken connection. This can save a lot of time when chasing electrical problems. A corroded or poor connector can have a drastic effect on the current available in the circuit.

Bill O. promised to pick up some contact cleaner at NAPA and do a proper cleaning of the connector. We are confident this will result in a proper 12 volts making it to the coil and the Corvair should be back to consistent cranking.
