TRAACA Tech Day: 1966 Ford Thunderbird Power Steering Pump Replacement By Craig Brown

August 26, 2017 Norm Madsen's Garage

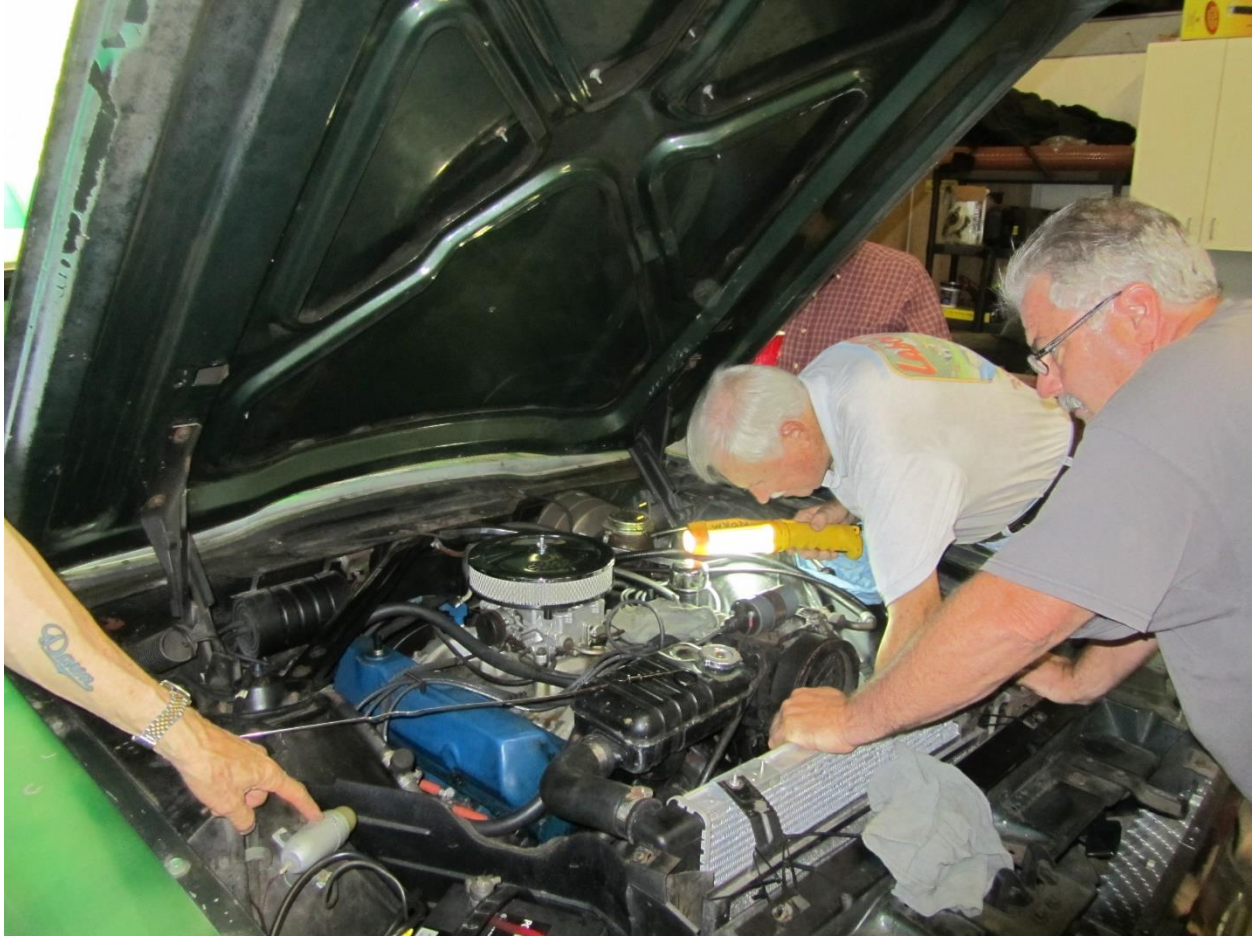
The goal for this tech day was to replace the power steering pump that was no longer functioning. The defective pump was still in the car and since the windshield wipers run off power steering pump pressure, neither the power steering nor the windshield wipers were operational.

Paul and Jack determined the best way to extract the old pump and had it out in record time. Strategic placement of cardboard and a drain pan underneath the Thunderbird caught the Type F transmission fluid that had not already leaked out. This is important because as we all know transmission fluid, much like blood, always looks like more than it actually is when spread over a garage floor.

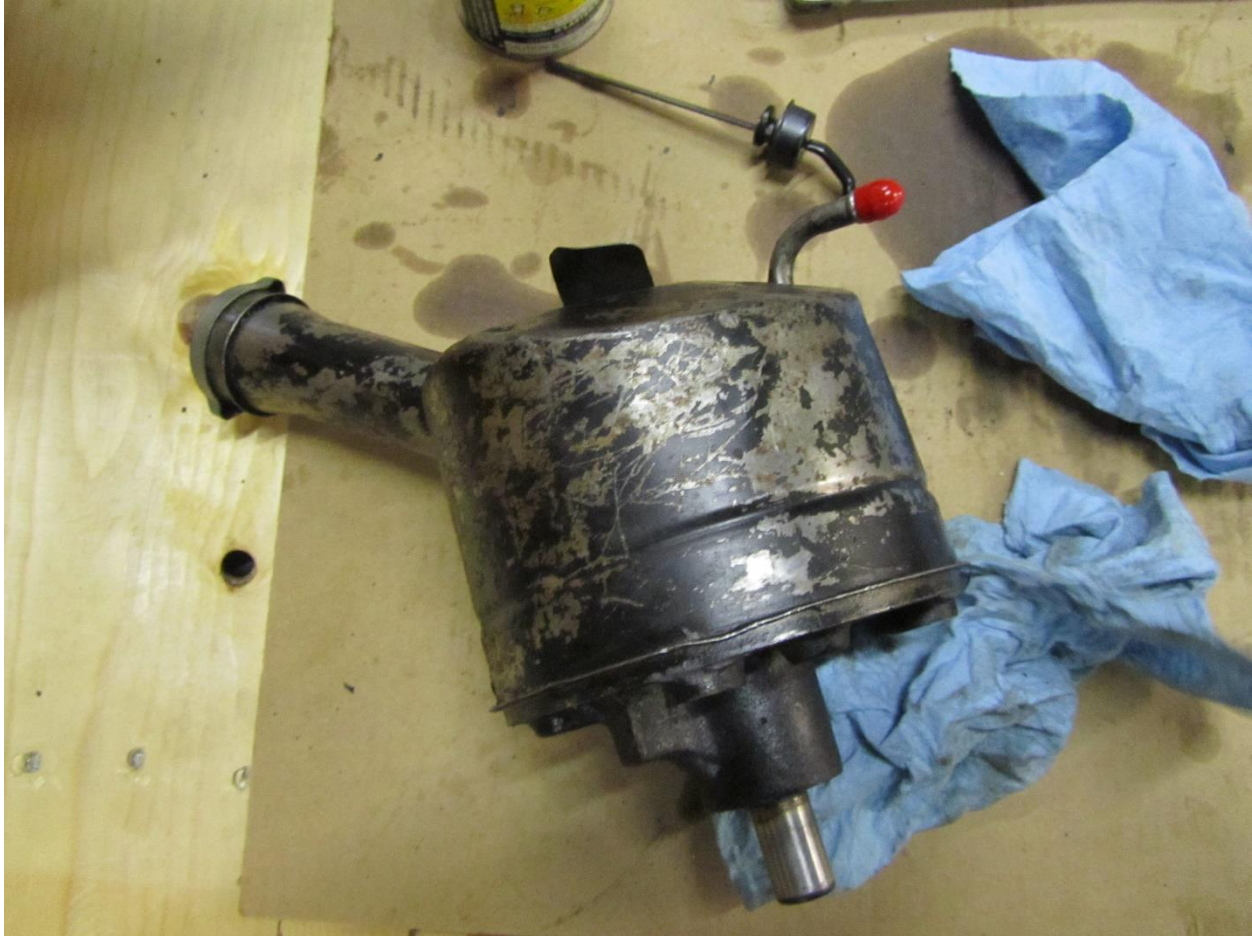
This is the old pump with the pressure hose and pulley removed. When checking the old part against the new, we carefully noted the location and thread pitch of the pressure side outlet and recognized the return line was 180-degrees opposite of the original. The return line pointing upward would actually make the installation easier. What we dismissed was the slight bevel on the back side of the old pump casing shown in the picture above. That missing bevel on the rebuilt pump was significant.

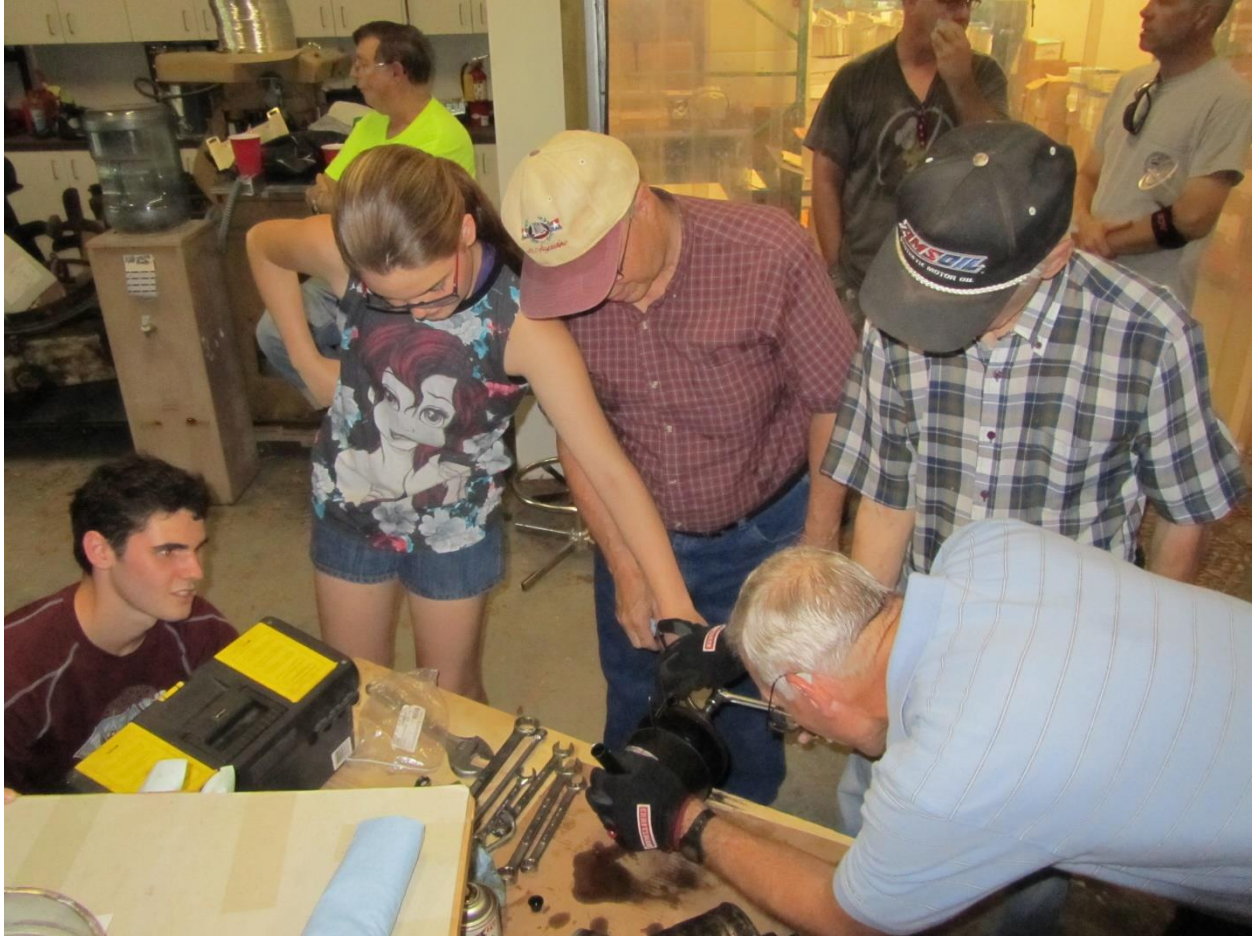
We had measured the clearance between the pulley and the pump casing with calipers to ensure the installation on the rebuilt pump would maintain proper drive belt alignment. In the heat of competition, the Thunderbird didn't need to throw off a belt! Seth, Ariana, Ken, Bill and Craig check the clearance and make the final adjustment above.

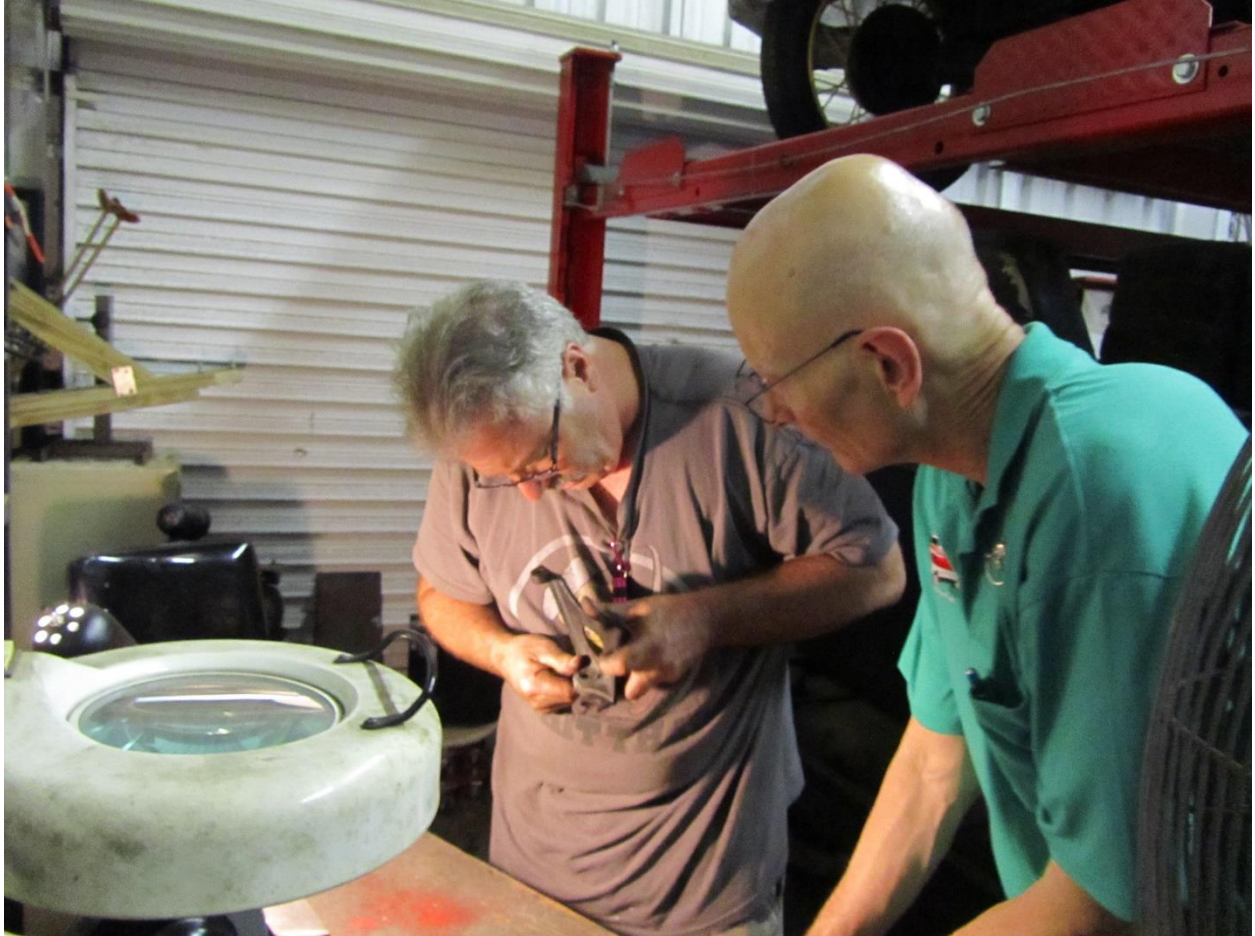
With the pressure hose loosely installed, it was time to put the rebuilt pump in the Thunderbird. Remember the slight bevel in old pump casing? The team quickly discovered the reason for the bevel while test fitting the pump. The bevel on the right side of the pump is to clear the mounting bracket and the bevel on the left is to clear the fender well. The new pump could be wedged in place, but it could not be moved enough to take up the slack in the drive belt.

It is not uncommon to have a part that is used in multiple models with slight variations for a particular model. The problem occurs when a replacement part is listed for multiple models and it will function in each model, but the replacement part does not have the variation specific to your application. Sometimes this is a minor inconvenience that makes installation difficult, sometimes it requires modification, and sometimes the part just can't be installed. The team decided this was a "requires minor modification" situation and decided to move forward.

The first alternative was to remove the pump mounting bracket and begin grinding to alleviate some of the clearance issue. Paul and Norm work on the bracket above.
