TRAACA Tech Day: 1966 Ford Thunderbird Power Steering Pump Replacement By Craig Brown

August 26, 2017 Norm Madsen's Garage

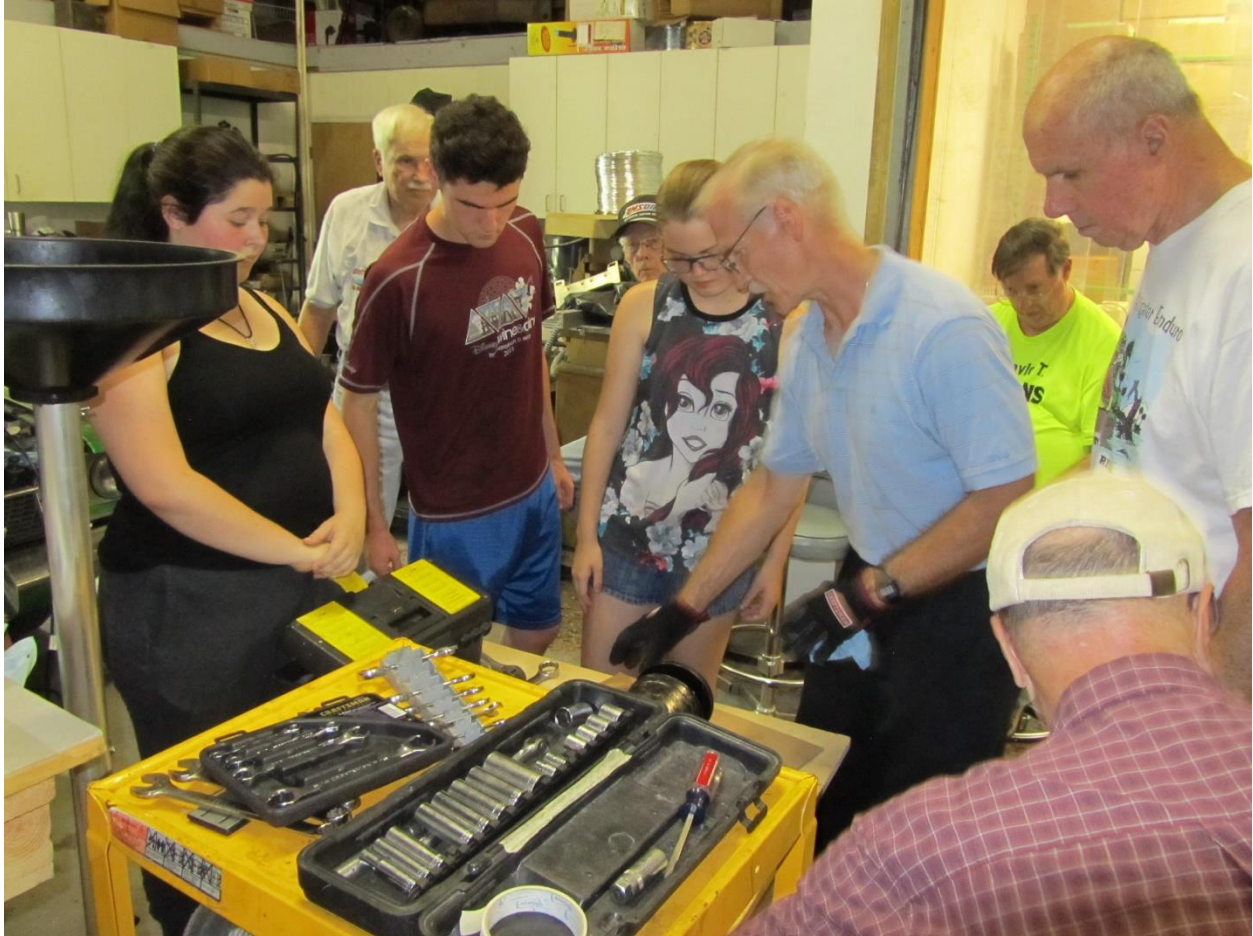
Paul and Jack determined the best way to extract the old pump and had it out in record time. Strategic placement of cardboard and a drain pan underneath the Thunderbird caught the Type F transmission fluid that had not already leaked out. This is important because as we all know transmission fluid, much like blood, always looks like more than it actually is when spread over a garage floor.

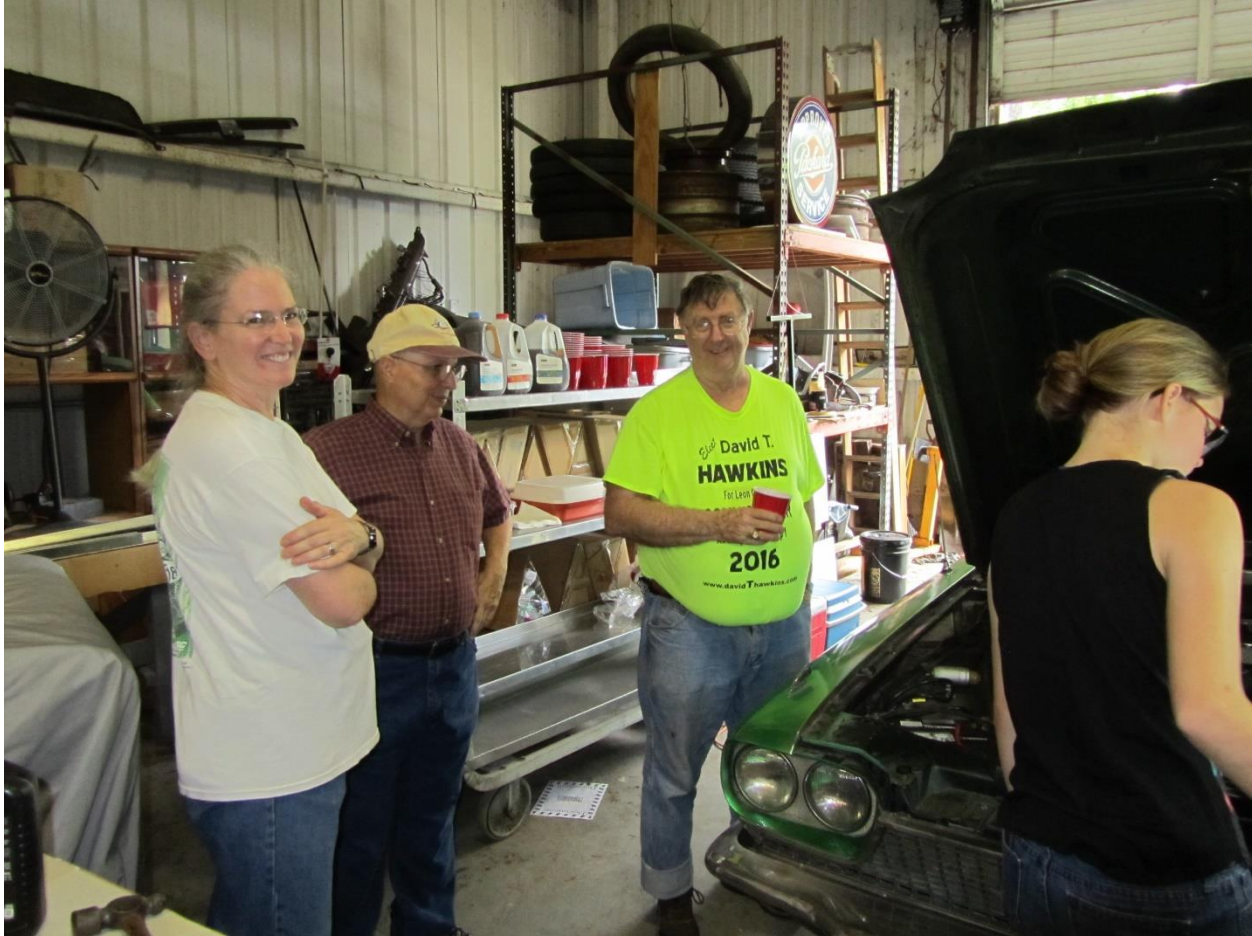
The smiles on Lori, Ken, Reuben and Ariana indicate success! After being filled with Type F automatic transmission fluid and cycled a few times to bleed air, the power steering worked well. Now that the windshield wipers had pressurized power steering fluid, they also worked.

Then it was time for the obligatory parts run to locate a shorter drive belt. This was necessary to minimize the amount of travel required by the power steering pump. Norm and Seth returned with a new drive belt that was exactly the correct length for the rebuilt pump. The bracket modifications allowed enough movement for proper tension.
